Investigation of the Corrosion Mechanism and Determination of the EMS Estimated Service Life at Site 81

February 2013

Final report

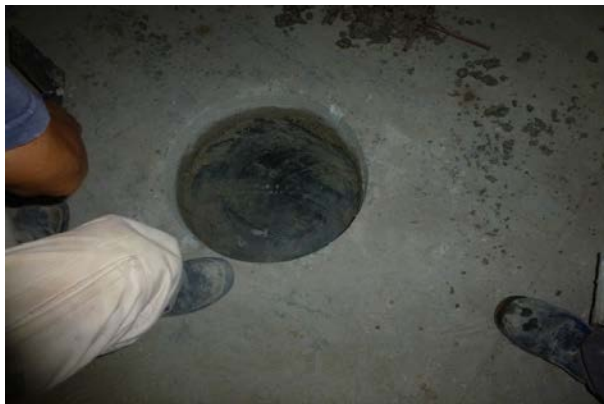
It was also determined that the site contractor had the capability of readily cutting 16 in. (40 cm) diameter core holes down to the EMS plate (Figure 9) which then could be readily removed to expose the plate. These larger access ports would also make later testing more efficient and accurate.

Figure 9. 16 in. diameter core hole cut to expose steel EMS for testing.

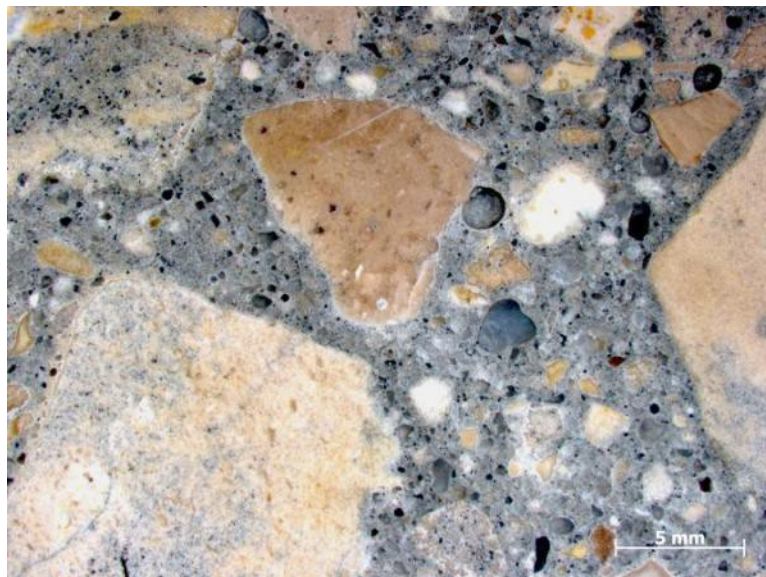
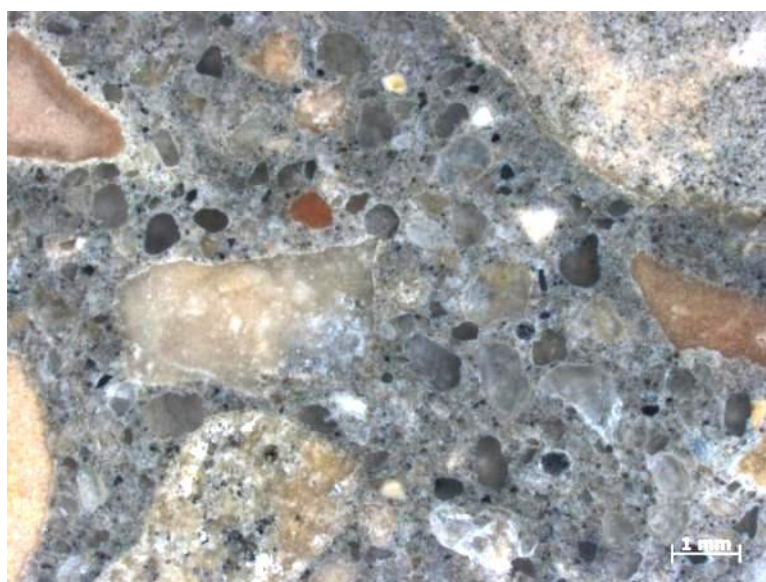
Figure 18. Photomicrographs of core sample #4 (5x above, 15x below).

Images of concrete from core sample #4 are shown in Figure 18. The concrete appears to be composed of an angular coarse and subangular-shaped fine aggregate of unknown composition. Some entrapped air is visible in the concrete. The concrete appears quite competent, with no visible cracks or signs of chemical reactions.

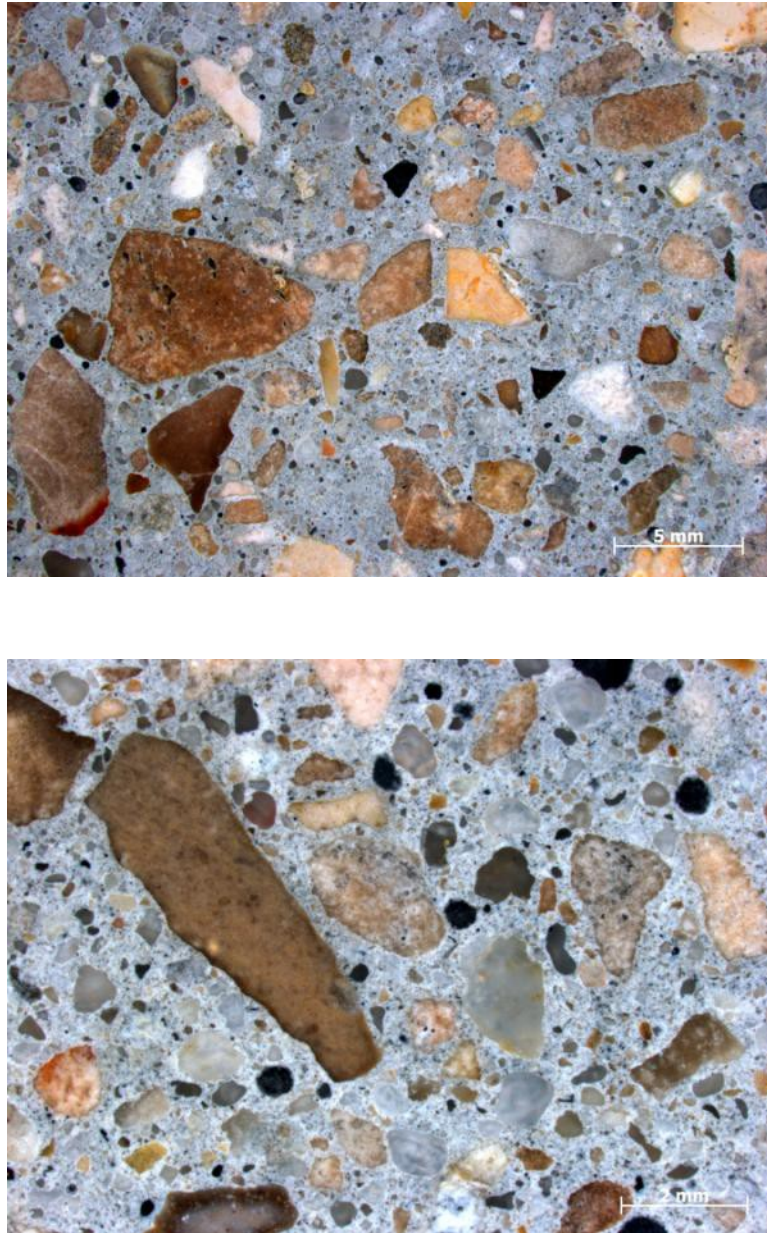
Figure 21. Photomicrographs of core sample #7 (5x above, 15x below).

Images of concrete from core sample #7 are shown in Figure 21. The concrete appears to be composed of an angular coarse and subangular-shaped fine aggregate of unknown composition. There appears to be very little air in the concrete. The concrete appears quite competent, with no visible cracks or signs of chemical reactions.

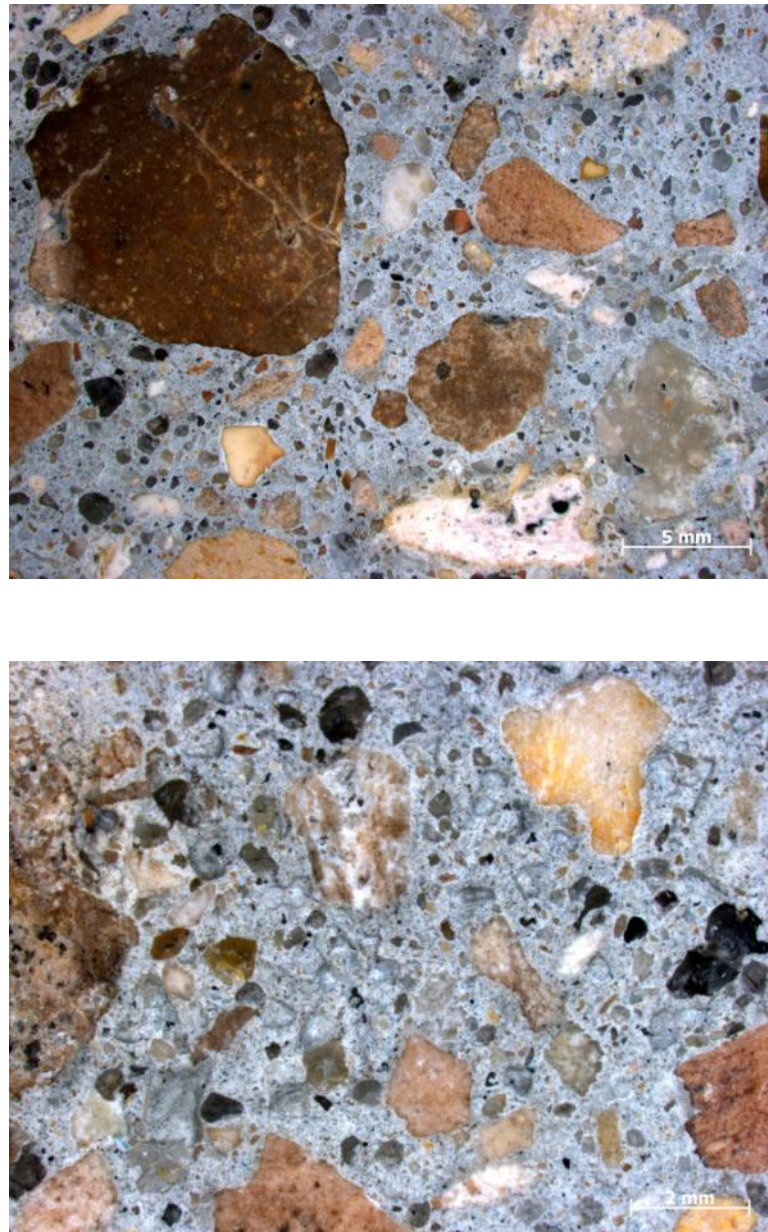
Figure 22. Photomicrographs of core sample #8 (5x above, 15x below).

Images of concrete from core sample #8 are shown in Figure 22. The concrete appears to be composed of an angular coarse and subangular-shaped fine aggregate of unknown composition. There appears to be very little air in the concrete. The concrete appears quite competent, with no visible cracks or signs of chemical reactions.

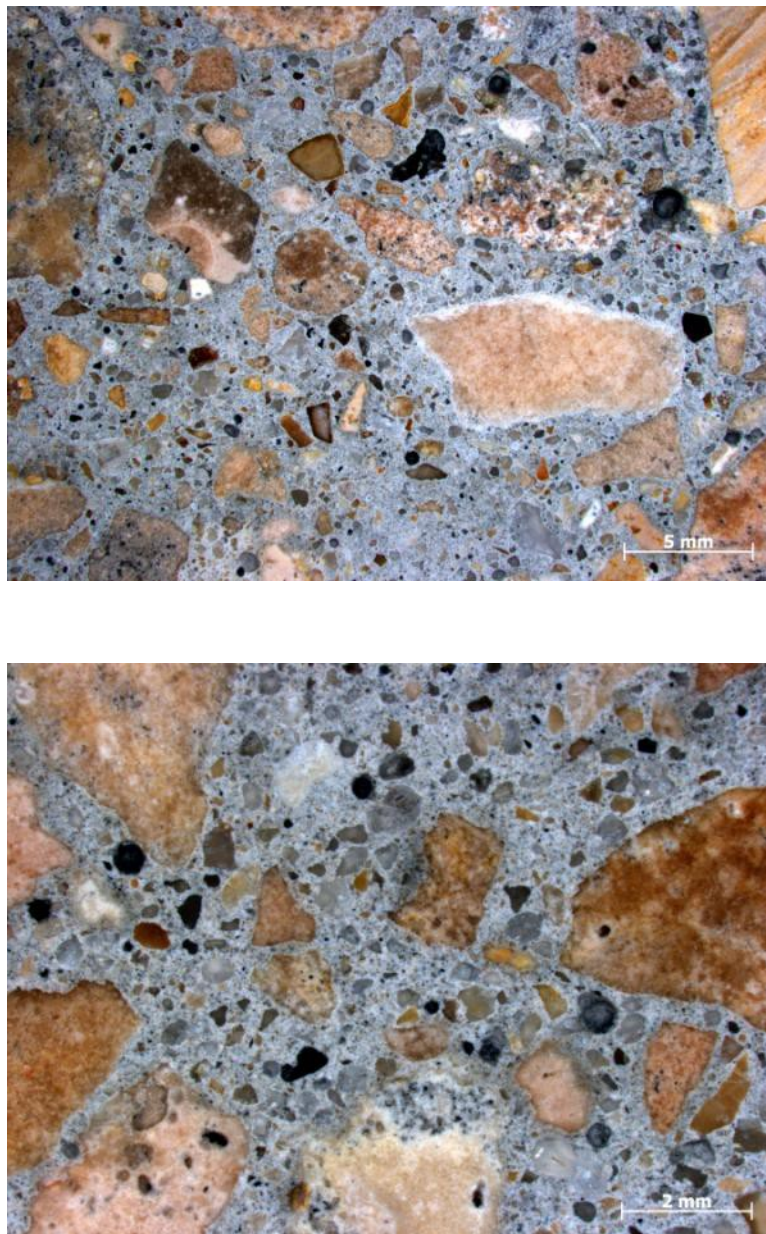
Figure 26. Photomicrographs of core sample #12 (5x above, 15x below).

Images of concrete from core sample #12 are shown in Figure 26. The concrete appears to be composed of an angular coarse and subangular-shaped fine aggregate of unknown composition. There appears to be very little air in the concrete. The concrete appears quite competent, with no visible cracks or signs of chemical reactions.

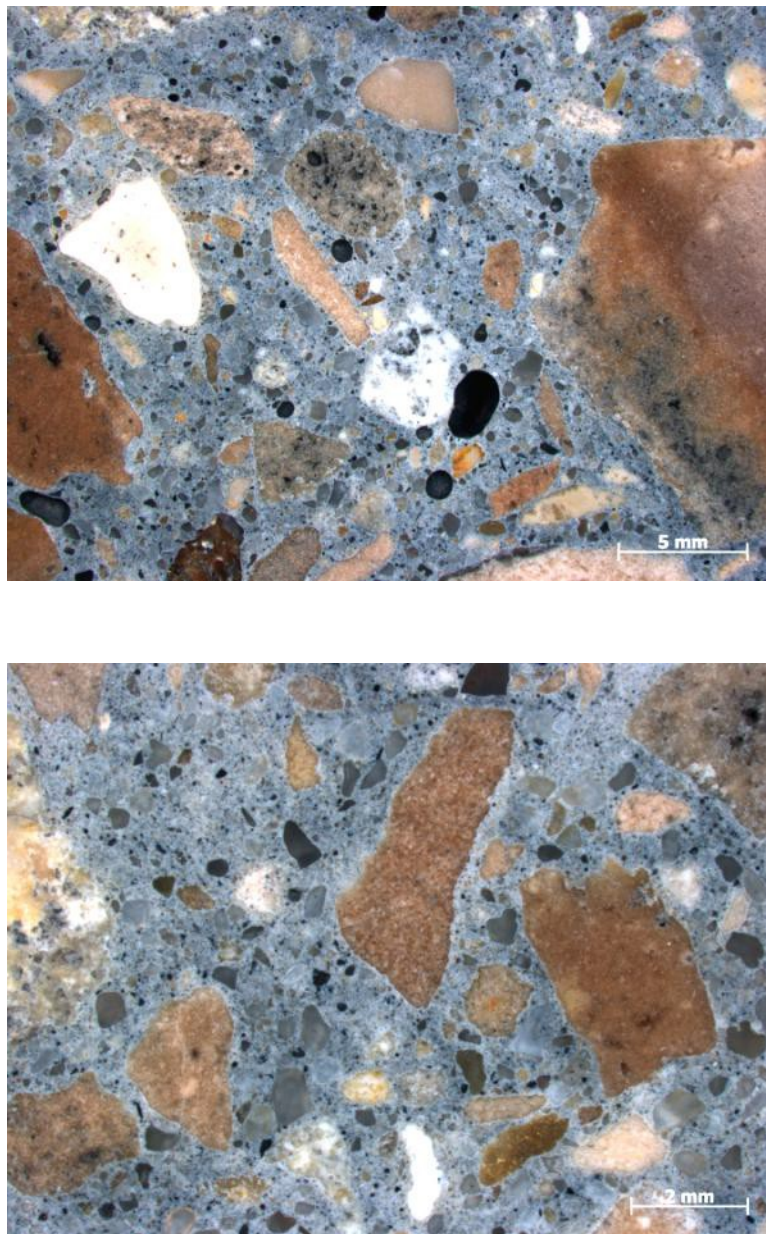
Figure 28. Photomicrographs of core sample #14 (5x above, 15x below).

Images of concrete from core sample #14 are shown in Figure 28. The concrete appears to be composed of an angular coarse and subangular-shaped fine aggregate of unknown composition. There appears to be very little air in the concrete. The concrete appears quite competent, with no visible cracks or signs of chemical reactions.

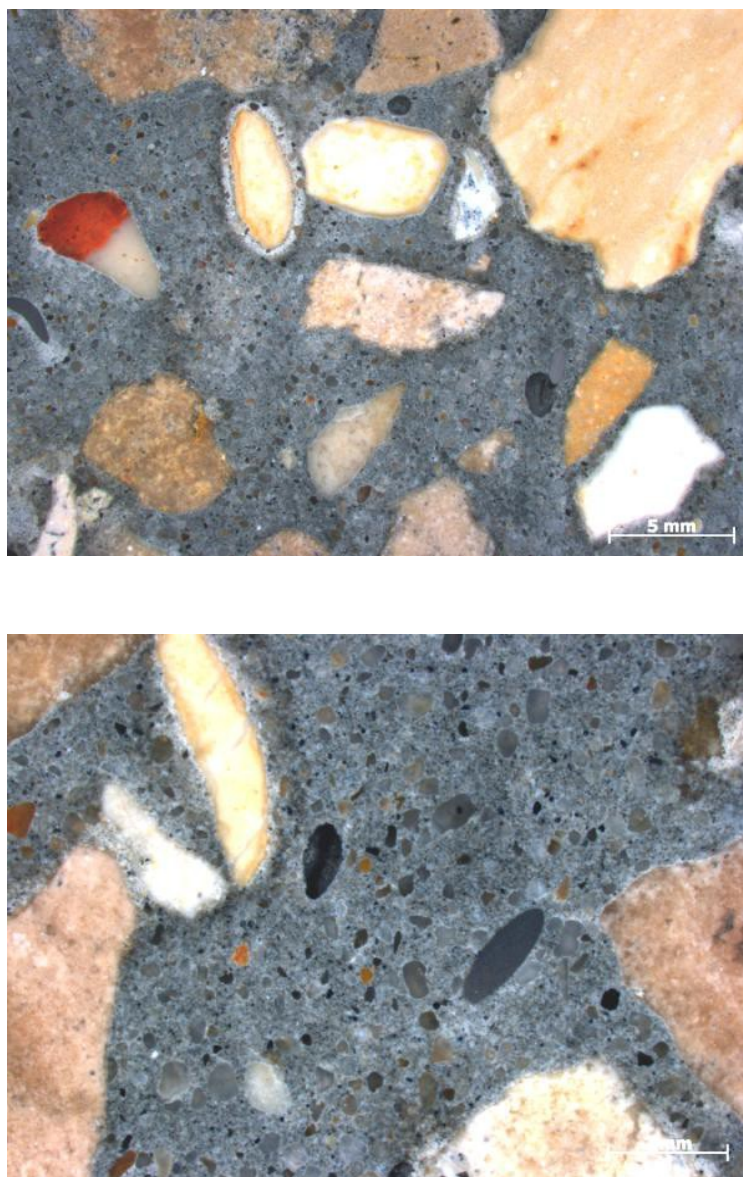
Figure 29. Photomicrographs of core sample #15 (5x above, 15x below).

Images of concrete from core sample #15 are shown in Figure 29. The concrete appears to be composed of an angular-to-rounded coarse and subangular-to-rounded shaped fine aggregate of unknown composition. Steel fibers are present in the concrete. There appears to be very little air in the concrete. Although the concrete appears competent with no visible cracks, there are areas in the cement paste around selected aggregate particles that are lighter in color than the surrounding paste.
